Hidden Crisis:

Unravelling past failures for future success in Rural Water Supply

Water point functionality: new tools and insights from physical science study of selected districts of Uganda

20th AfWA Congress and Exhibition 24-27 Feb 2020

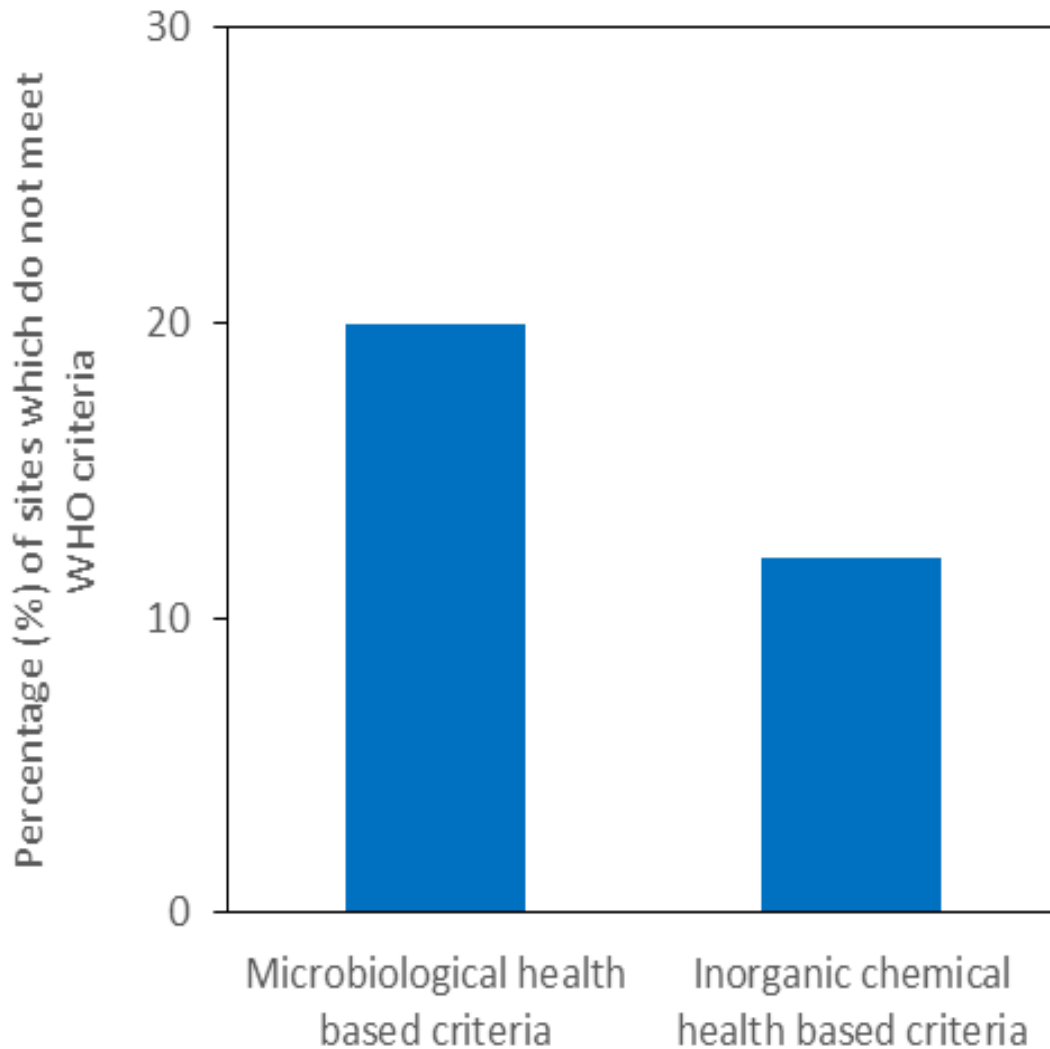
Water Quality

- **Inorganic water quality** is good with only **12%** of sites **failing** WHO standards of water quality indicators;
- **Pathogen** contamination affect **20%** of sites;
- Improved well construction and completion could help improve issue;

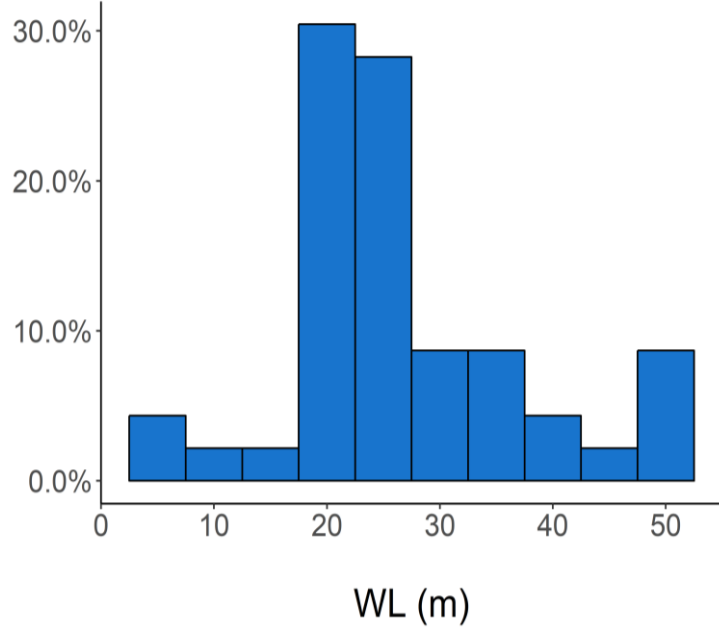
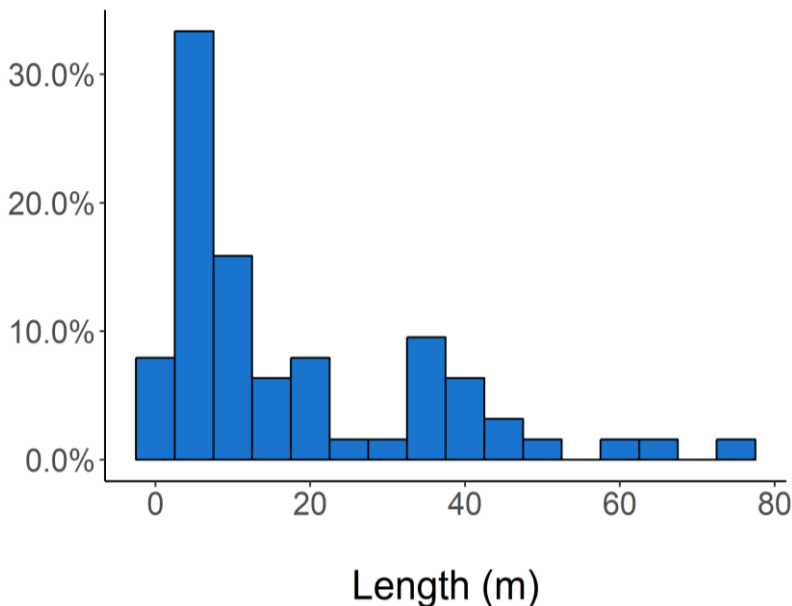
Water point construction

- Average borehole depth is **55 m**, and average length of screen or uncased section across sites ranges from **10 to 20 m**;
- **10%** of HPBs had screen or uncased section length **<3 m**, but with no observed impact to functionality performance;
- **Pump depth from 20 to 30 m bgl**;
- Where **pump depth >40 m bgl**, **depth to groundwater** is generally still **>20 m bgl** - operational conditions are within handpump specification and capacity;

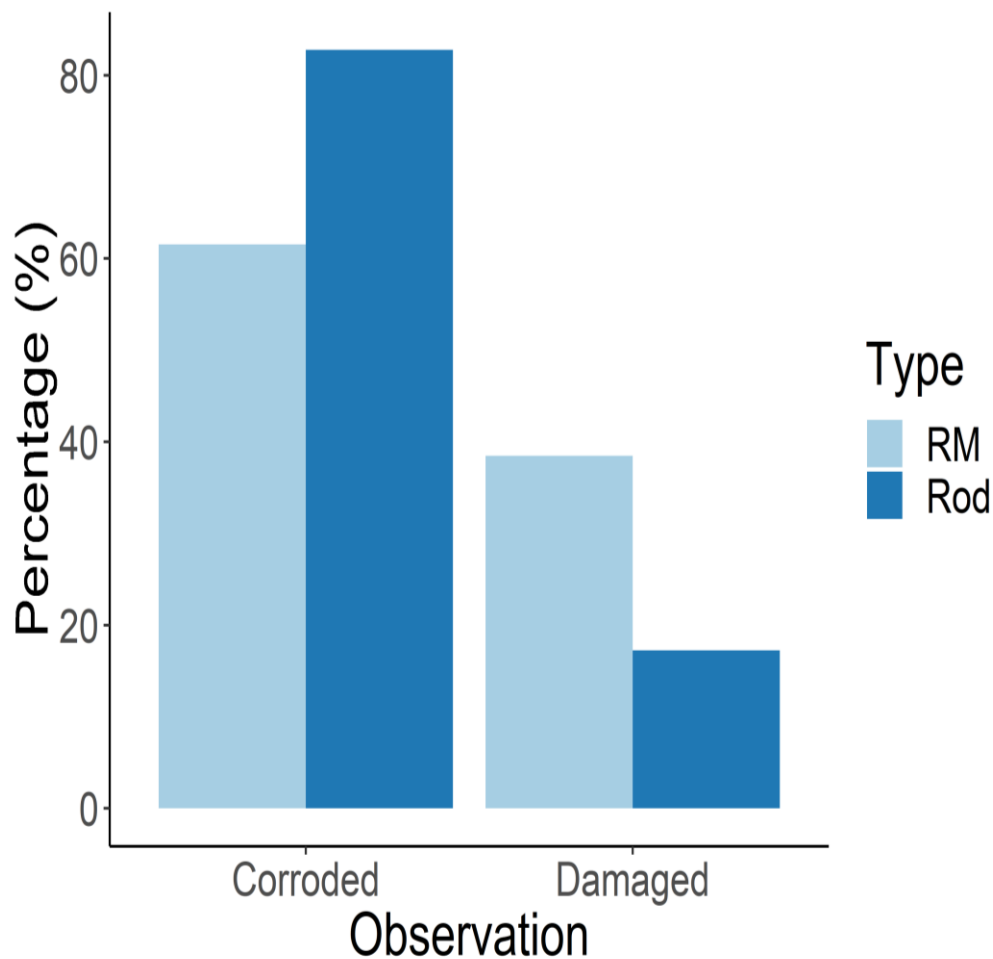
HPB Condition

- **Corrosion** and **general damage** affected handpump components in **>75%** of the HPBs;
- **Rising main** sections and **pump rods** were significantly affected by **corrosion**, with **>60%** being in poor condition;

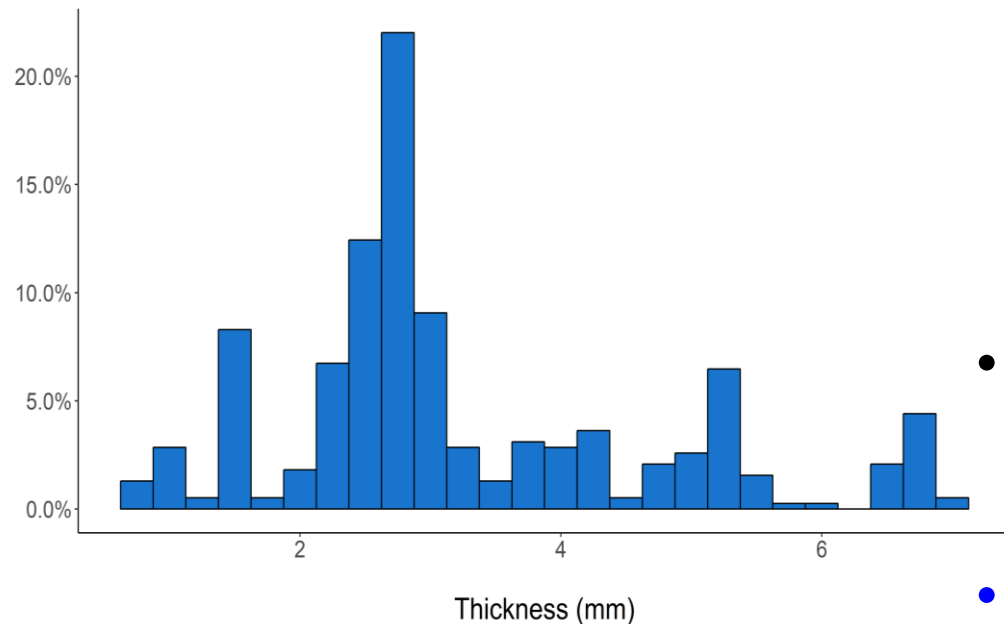
IM2 RM Thickness

- **Variable material competency** in **>90%** of HPBs (from corrosion, manufacturing variability) – potential for damage;
- Significant variation (**±75%**) in **thickness of rising main sections**;
- **65%** of handpumps had rising main **thickness less** than India Mark II specification (**3.25 mm ±0.2 mm**).
- Galvanised thickness of rising mains was **below** India Mark II specification (**70-80 µm**) in **>90%** of handpumps;
