Hidden Crisis:

Unravelling past failures for future success in Rural Water Supply

Water point functionality: new tools and insights from physical science study of selected districts of Uganda

20th AfWA Congress and Exhibition 24-27 Feb 2020

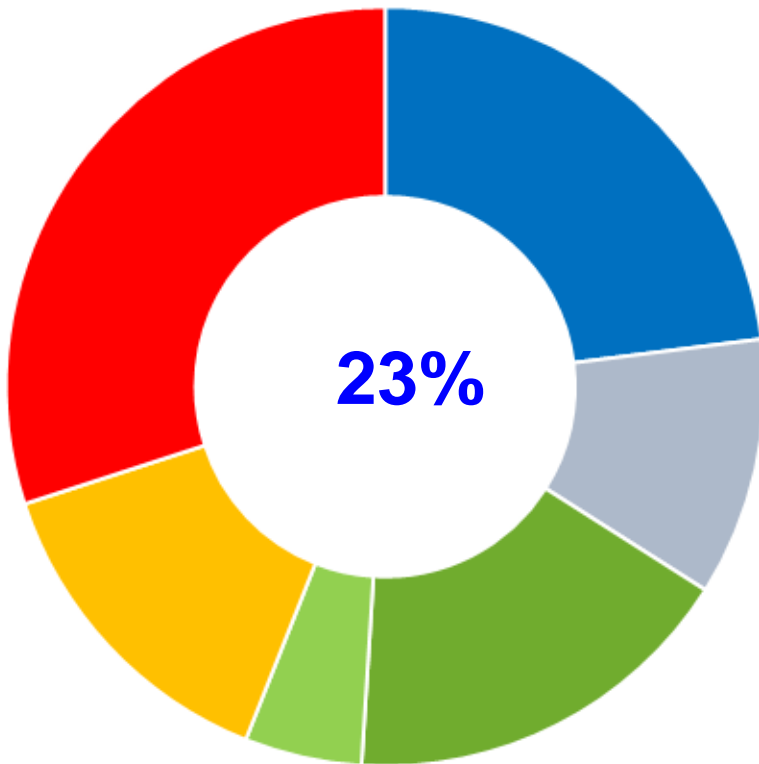
Category	Criteria	%
Basic	HPB working on day of survey (yes/no)	55
Snapshot	HPB works with sufficient yield (10 L/min) on day of survey	34
Functionality performance	HPB with sufficient yield (10 L/min); reliable (<30 days downtime in last year) or abandoned (not worked in past year)	23
Functionality including water quality	All above and passes WHO inorganic parameters, and TTC standards.	18

- Fully functioning
- good yield, unreliable
- poor yield
- poor yield , poor reliability
- No Flow but worked in last year
- Abandoned - no flow in last year

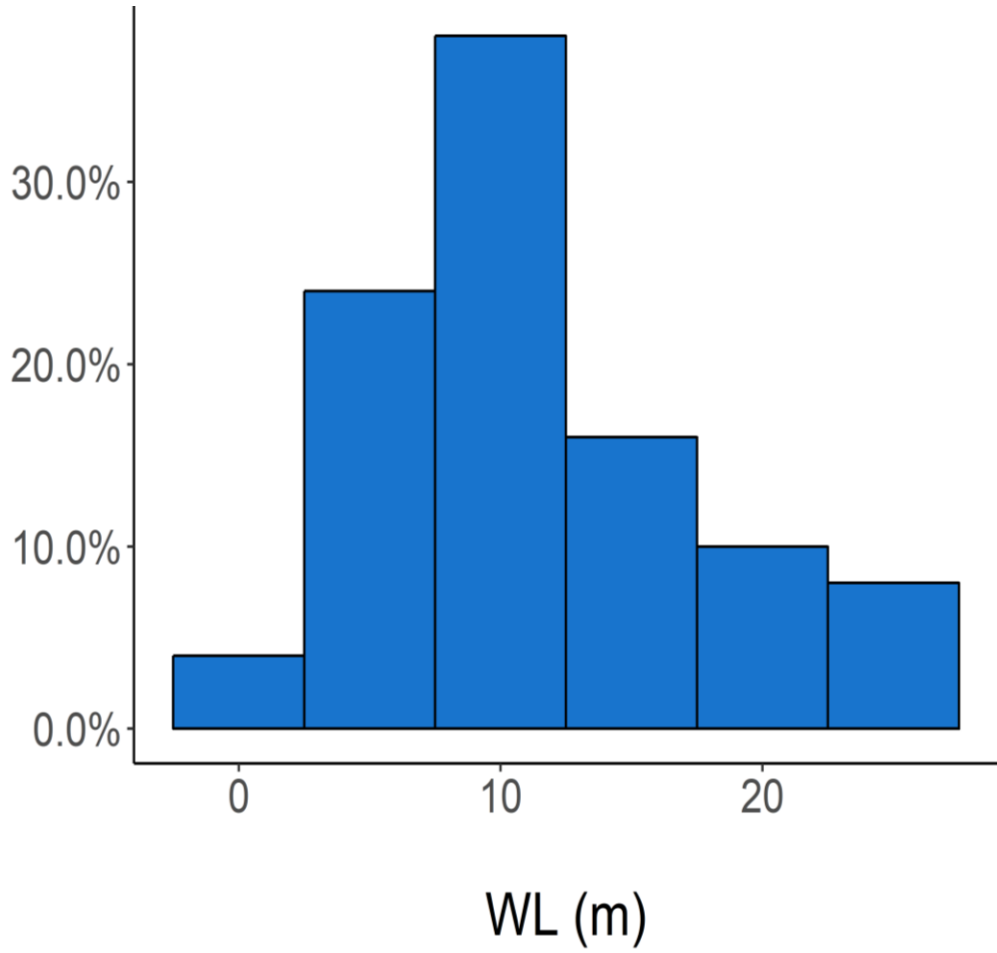
Depth to groundwater

Generally quite shallow with **mean depth of 10 m bgl** - which is optimal for the operation of handpump mechanisms;

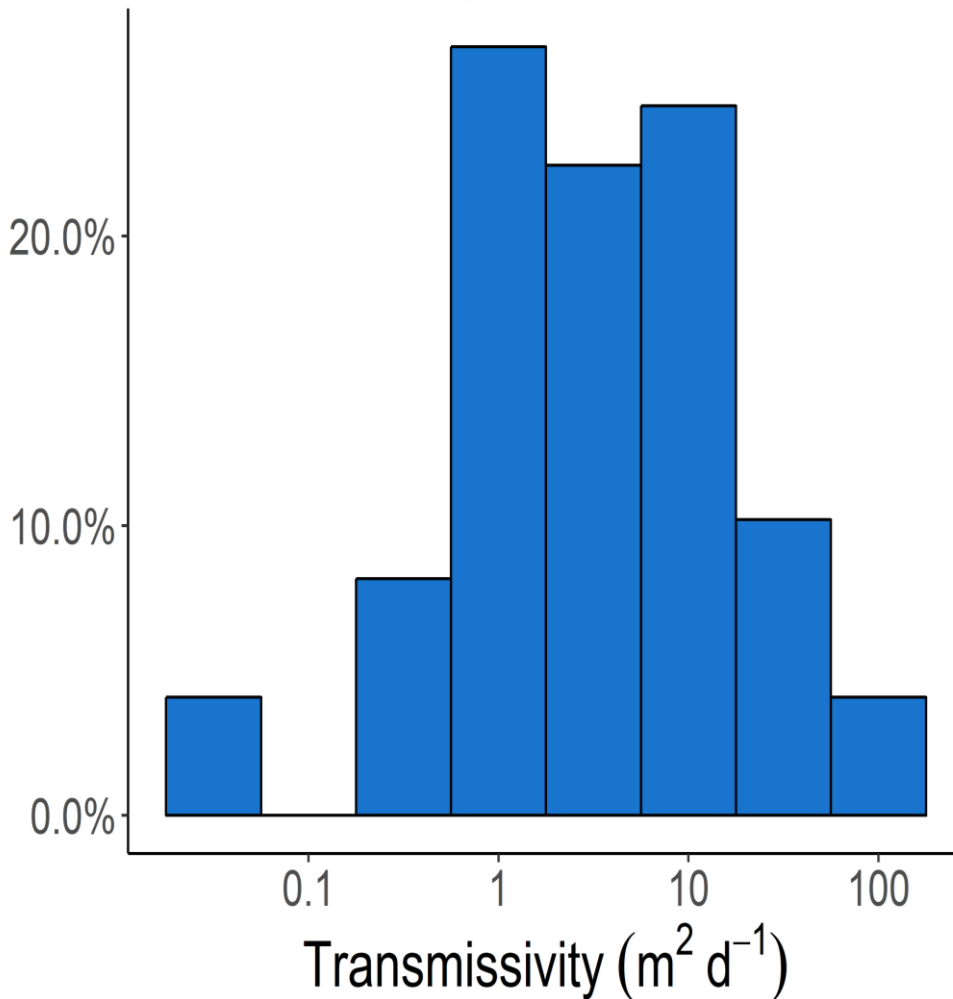
Aquifer transmissivity

- Significant variability between sites reflect heterogeneity of weather basement aquifer;
- **Median** and **Mean T value of 4 m²/d and 10 m²/d**, respectively;
- Overall, **70%** of sites have sufficient **T value (>1.5 m²/d)** to meet demand of community water supply;

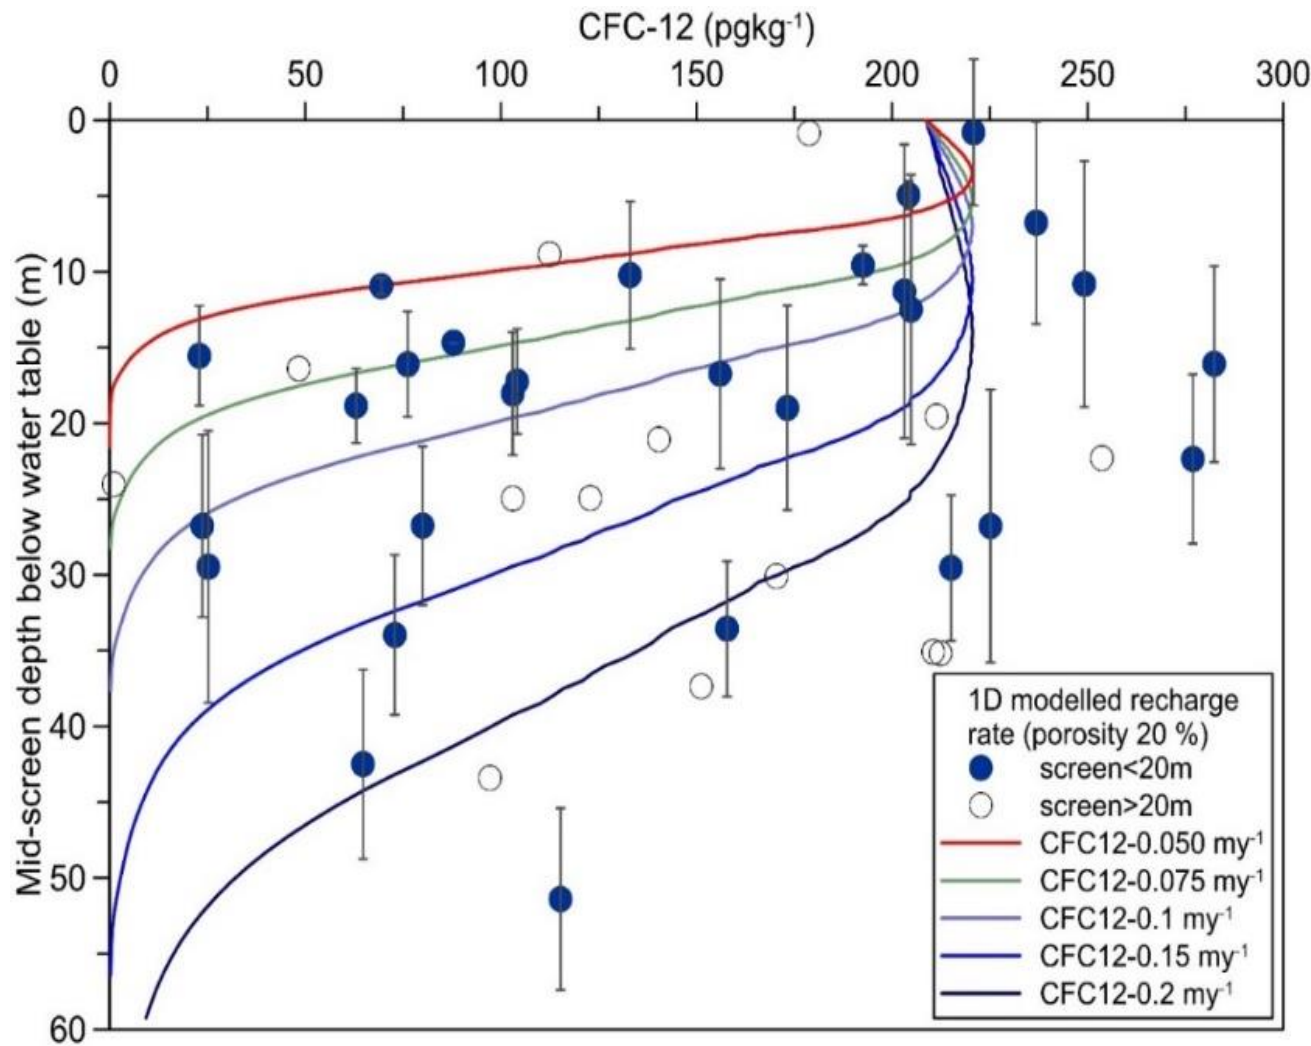
Resource resilience – climate and abstraction

- Generally resilient to climate variability for yields associated with drinking water.
- Groundwater is a mix of modern (<50 years old) and older water;
- Indicate active recharge of several mm per year;
